APOLLO SERVICE MODULE ROCKET ENGINE (u)

Monthly Progress Report

Report 3865-01-22

AEROJET-GENERAL CORPORATION

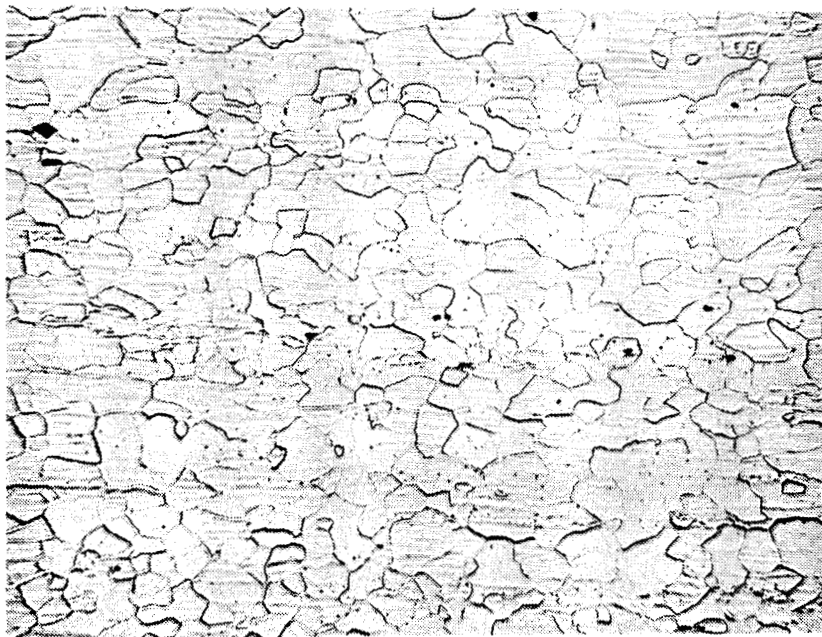
C-129 0.015 Fusion Zone and Heat Affected Zone (500X)

C-129 Parent Metal Adjacent to the Weld (500X)

Photomicrograph of C-129 Weld

The ductile-to-brittle transition temperature of C-129 columbium has been determined to be below -320°F. Welding has been very successful with the welds withstanding a 1/2 t bend in the as-welded condition. Figure 3 is a photomicrograph of a C-129 weld. The success of this weld is the fact that the black spot, Yttrium oxide, holds the oxygen in solution. It can best be described as grease in water. The existence of Yttrium in columbium improves weld ductility because the Yttrium "grabs" all the oxygen and suspends it in the grain. Without Yttrium, the oxygen will go to the grain boundaries and result in poor ductility.
